# Independent Technology Service Inc.

## **SERVICE / WARRANTY BULLETIN**

DC Brush Motor Failure

Common DC Brush Motor Failures – Motor Burn Out

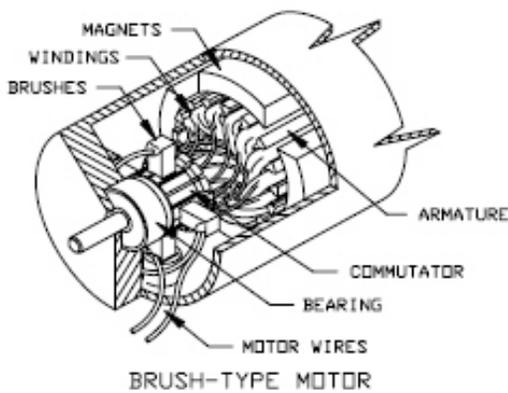
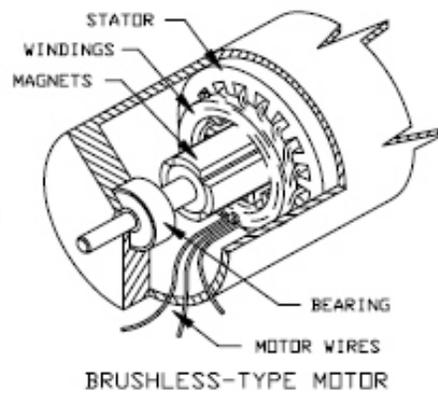
With all electric motors, the motor torque generated is a product of electric current and the amount of voltage determines the motor RPM. One of the basic differences between the brush and brushless motor is the configuration of the electromagnetic coils. With a Brush motor, the coil windings are part of the rotating armature and are deep inside the motor. With the brushless motors, the coil windings are not deep inside the motor since they are not part of the rotating armature. Because of this major design issue, the brush motor has a work load limitation. By having the coil windings deep inside motor, it dramatically reduces the amount of heat escaping from inside the motor. The trapped heat builds up to the point of melting the wire insulation, which in turn can cause an electrical short circuit. This is apparent when you open the back of the motor and it smells burnt. Sometimes you'll see a couple of teaspoons of a brown liquid from the humidity and insulation burning.

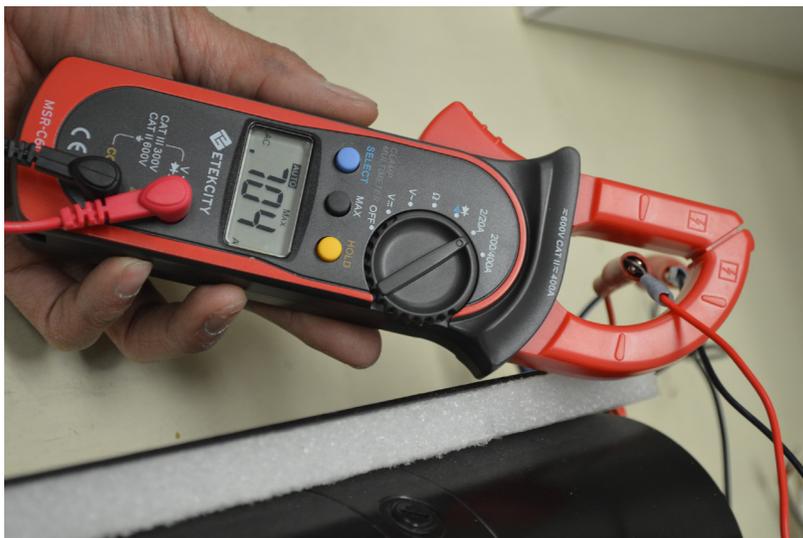
An installed meter reading a constant .704 amps

Install the meter as shown over the motor wires and begin by moving the machine. Enter a program to move the axis back and forth to a full travel. Lower the feed pot and start by moving at a slow speed. Observe and record, then increase the feedrate for more samples.
